VISUAL BUILDING INSPECTION REPORT

Complies with Australian Standard 4349.1

Inspected Property:

4 John Street, Johnson

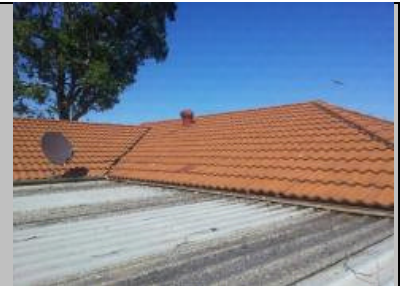
The roof is of pitched and skillion construction.

The overall condition of the roof coverings is fair.

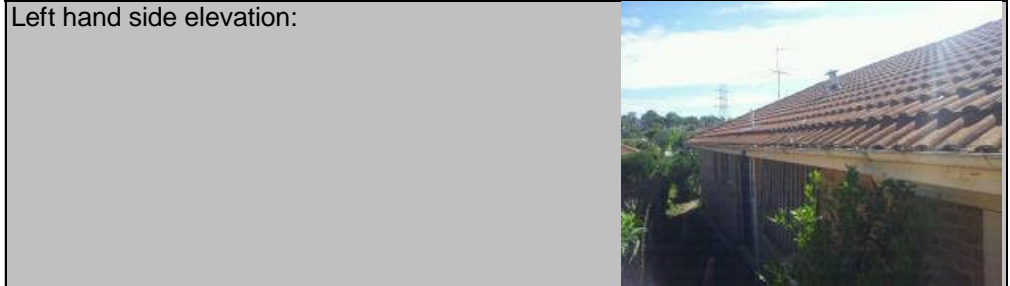
Left hand side elevation:

Appear to be in serviceable condition. Downpipes appear to be connected to the stormwater dispersal system, however, correct connection can only be confirmed with a smoke test. Leaves and debris are present in gutters. These should be cleared.

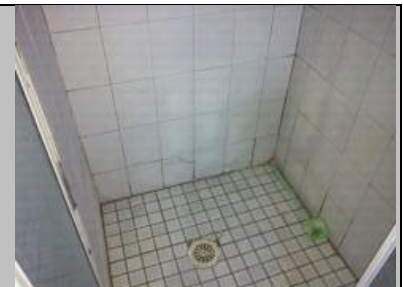
Evidence suggests the shower recess is leaking. Continued leakage may allow damage to surrounding components. As a guide, the cost to repair a leaking shower can be upward from \$1800.00 plus the cost of tiles. Where framing timbers are present and damaged, additional expense may be involved.

Some cracked tiles were noted in this area.

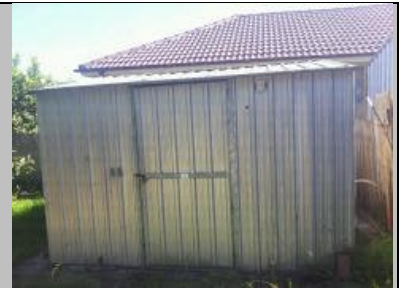
Metal garden shed:

The structure is generally in fair condition.

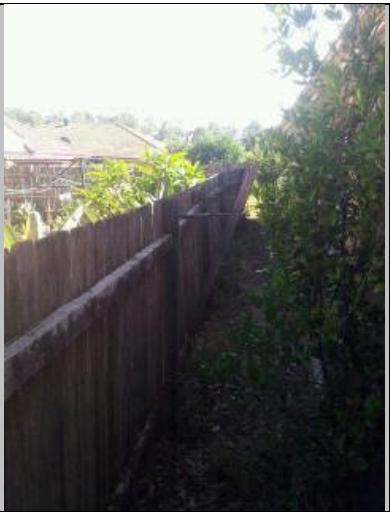
Left hand side: Rear section:

The fences are mainly constructed from timber. The fences are leaning and repairs are required. Repairs to fences are required.

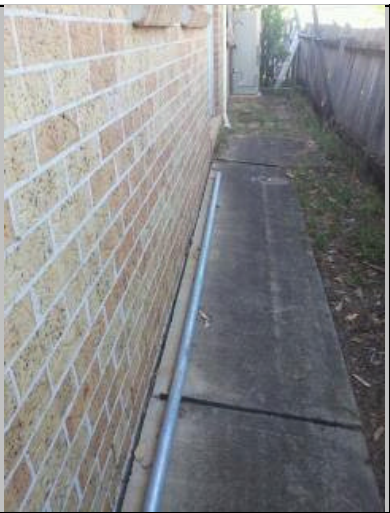
The concrete paths/paved areas have subsided in areas and will require repair. This may present a tripping hazard. Rectification should be considered.

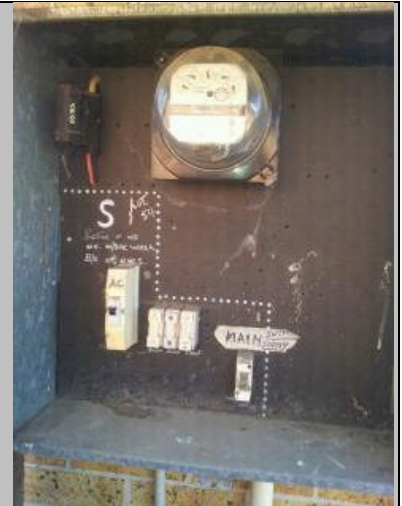
Smoke detectors are fitted however, the positioning, operation or adequacy was not tested and is not commented on. No residual current device (RCD) was noted in the electrical meter box. Whilst not necessarily required at the time of construction, it is recommended that an RCD be fitted. Please contact a Licensed Electrical Contractor for further information. Air-conditioning is installed in the premises but has not been inspected.
